INDOOR AIR QUALITY ASSESSMENT

**Hull Public Library
9 Main Street
Hull, Massachusetts**

Prepared by:
Massachusetts Department of Public Health
Center for Environmental Health
Emergency Response/Indoor Air Quality Program
July 2005

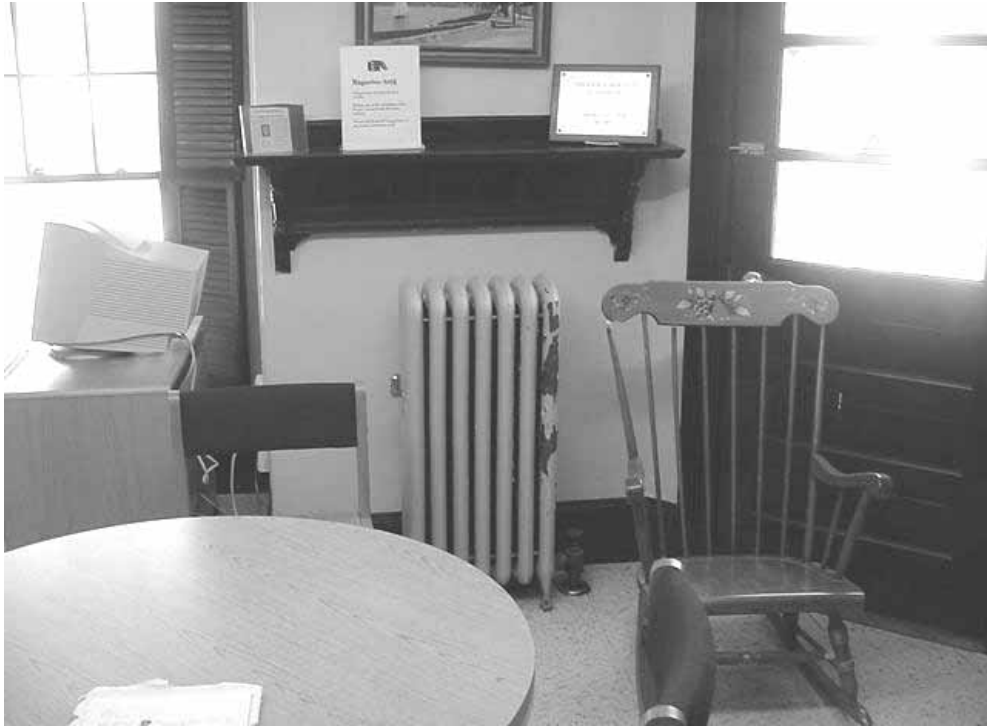
Picture 1

It can be seen from Table 1 that carbon dioxide levels were below 800 parts per million (ppm) of air in all areas surveyed, indicating adequate air exchange; however, no mechanical ventilation systems exist in the building. Ventilation is provided by openable windows. Ceiling fans are installed in several rooms to aid in air circulation. The original building is heated by cast iron radiators (Picture 1). The 1981 wing is heated by two wall-mounted electric heaters (Picture 2).

Cast Iron Radiator

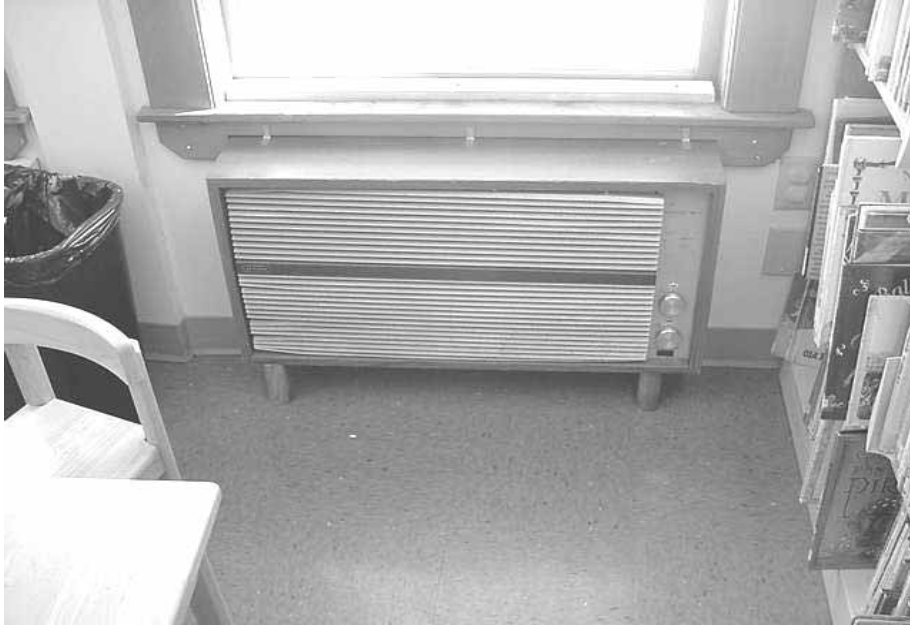
Picture 2

Electric Heater

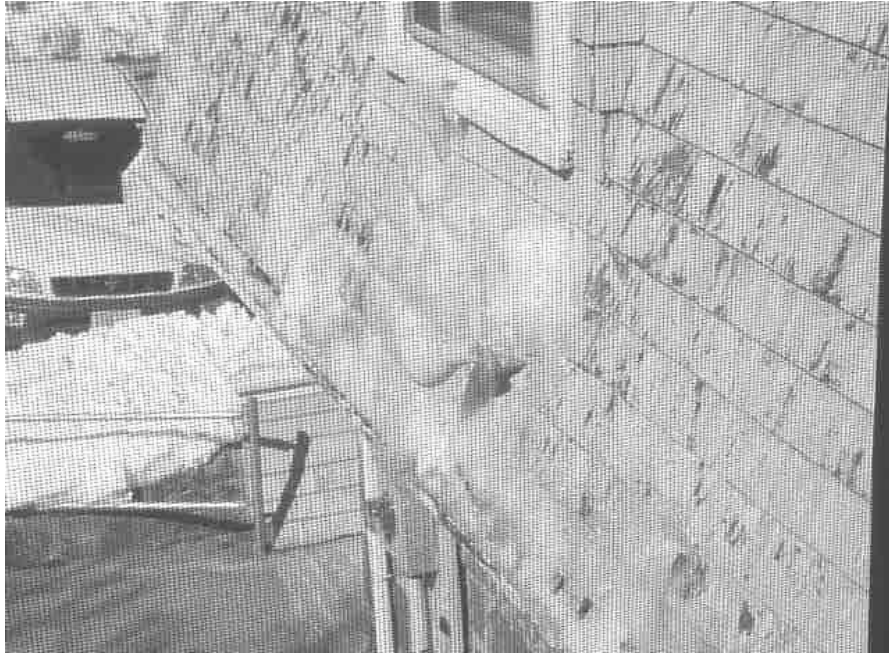
Picture 3

Significant ice dams were noted on roof edges (Picture 3) during the assessment, which can potentially lead to water penetration and subsequent damage. However, no water damage was observed in the attic, first or second floors of the building. The design of the Mansard-type roof places the lower section of the roof *outside* the plane of the exterior walls and the steep angle of the lower section of the roof helps prevent water accumulation inside the building

Ice Dams on Roof at Rear of Building above Bulkhead to Basement

- b) Fill in cracks and crevices along the foundation/exterior walls.
 - c) Install gutters and downspouts to direct rainwater at least five feet away from the foundation. Gutters should extend along the entire roof edge.

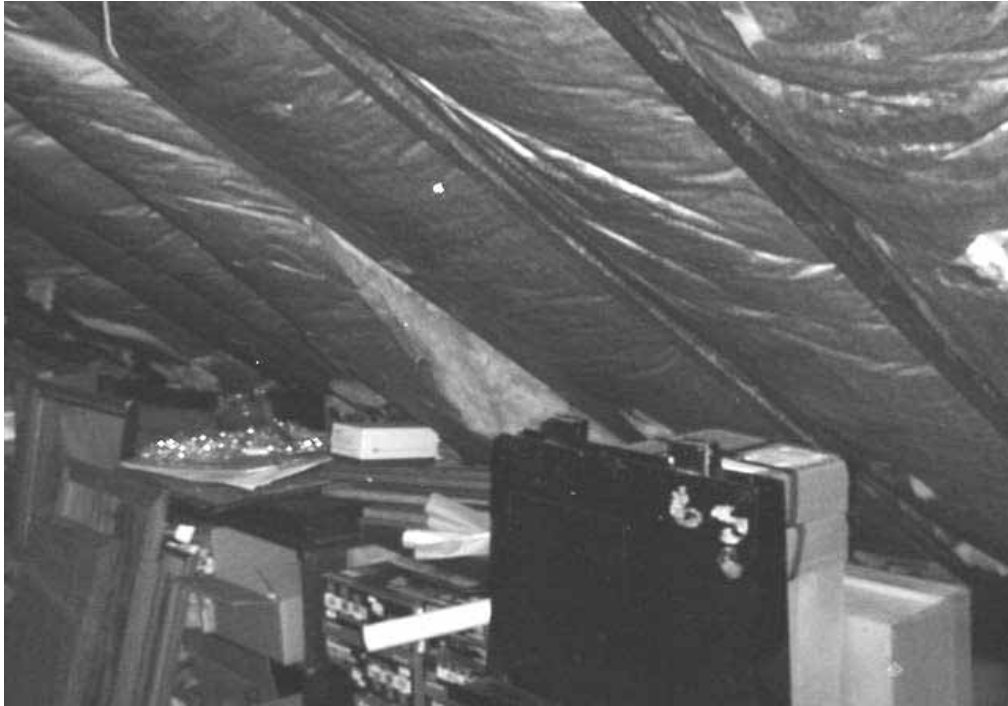
Picture 4

envelope. It is likely that loose fiberglass insulation installed in the attic may enhance the creation of ice dams. The temperature measured in the attic was 70 ° F, indicating significant heat penetration from the occupied areas as well as solar heating of the roof surface. Insulation was found hanging from the roof surface (Pictures 4 and 5). To prevent temperature transference insulation needs to be installed in contact with the intended surface.

Insulation Hanging Between Rafters of Roof

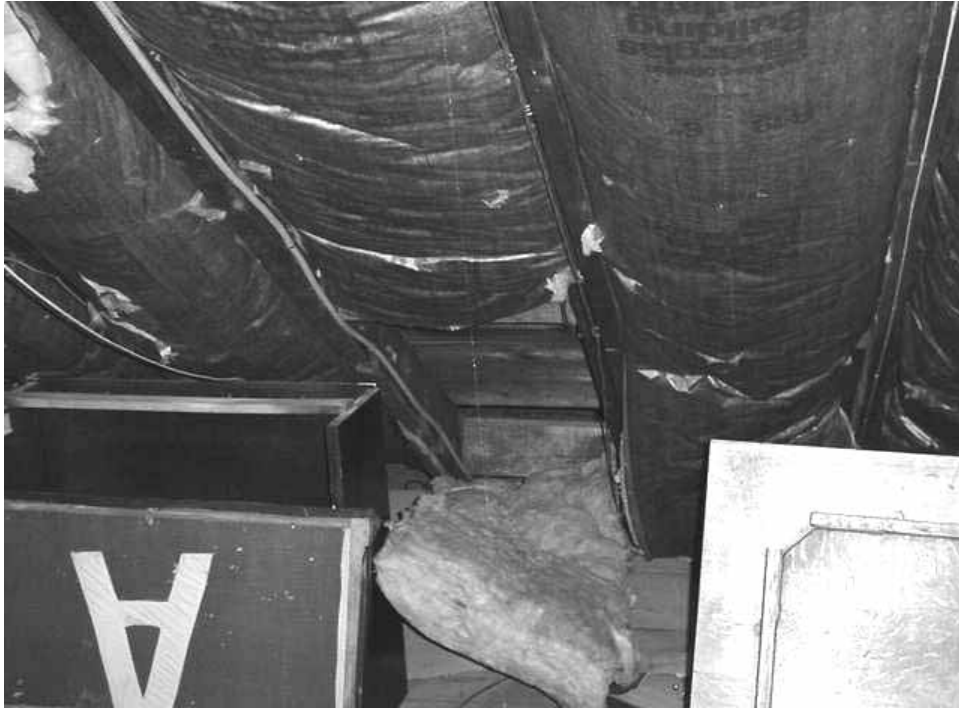
Picture 5

Insulation Hanging Between Rafters of Roof

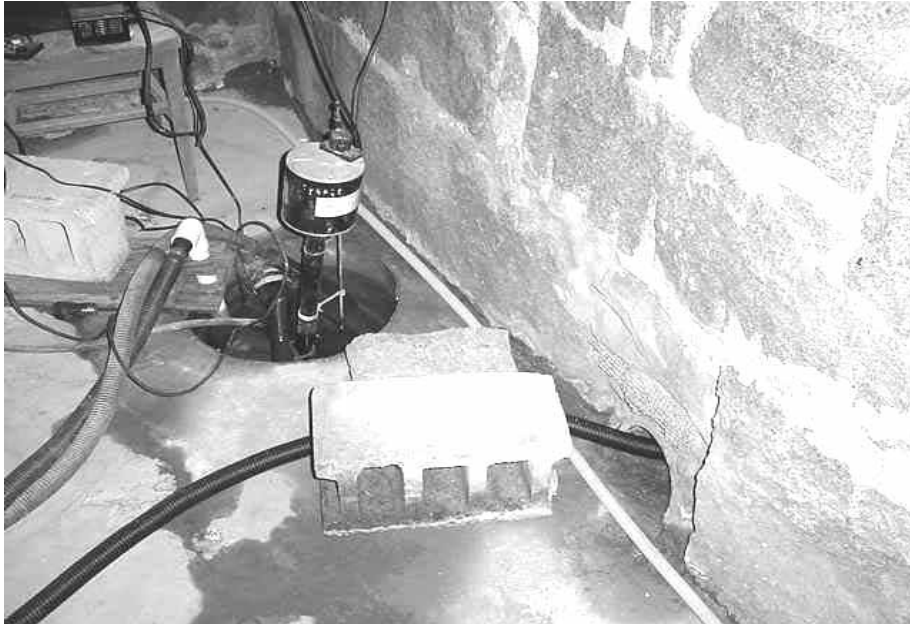
Picture 6

Relative humidity measurements in the basement were 28 percent, with an outdoor relative humidity of 14 percent. These measurements indicate that a moisture source exists. A number of sources of standing water were noted in the basement, including a filled sump pump (Picture 6) and water in a trough that was cut along the foundation floor (Picture 7), reportedly as an aid to water drainage. With a variety of standing water sources in the basement, stored porous materials and/or building components can become chronically moistened. Of note is a gypsum wallboard (GW) material that was installed on the ceiling of the basement above the furnace, which showed signs of mold-colonization (Picture 8). GW is prone to mold colonization and should not be used as a building material in an area that accumulates water.

Sump Pump in Basement, Note Water Level and Drain to Remove Water in Foundation Wall

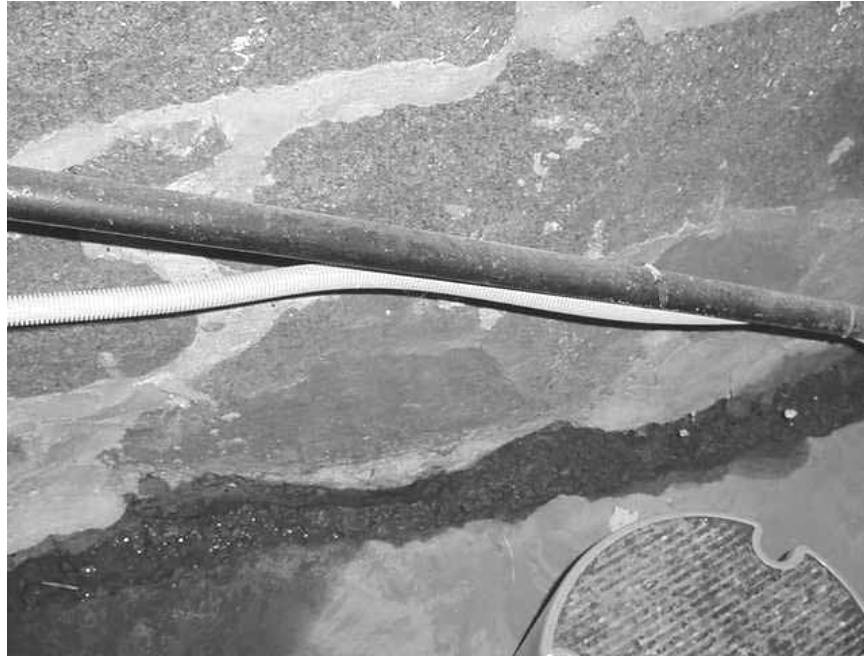
Picture 7

Water Trough Cut In Foundation Floor To Aid Water Drainage, Note Standing Water In Trough.

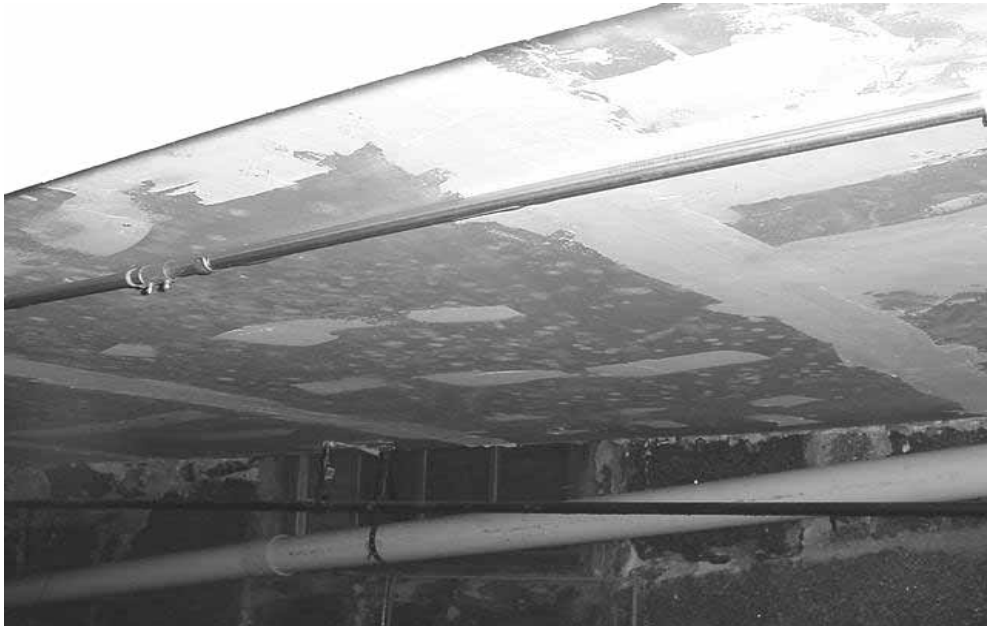
Picture 8

In order to become colonized with mold, a material must be exposed to water and remain moist. If sufficiently moistened, porous materials such as GW can support mold growth (US EPA, 2001). The US EPA and the American Conference of Governmental Industrial Hygienists (ACGIH) recommend that porous materials be dried with fans and heating within 24 to 48 hours of becoming wet (US EPA, 2001; ACGIH, 1989). If porous materials are not dried within this time frame, mold growth may occur.

Mold Colonized Gypsum Wallboard on Ceiling of Basement

1. Use of the fan should be discontinued to decrease pressurization of the basement.
2. Remove the GW from the basement ceiling as planned. Use a material other than GW (e.g., cement board) that is not prone to mold growth as a replacement material.

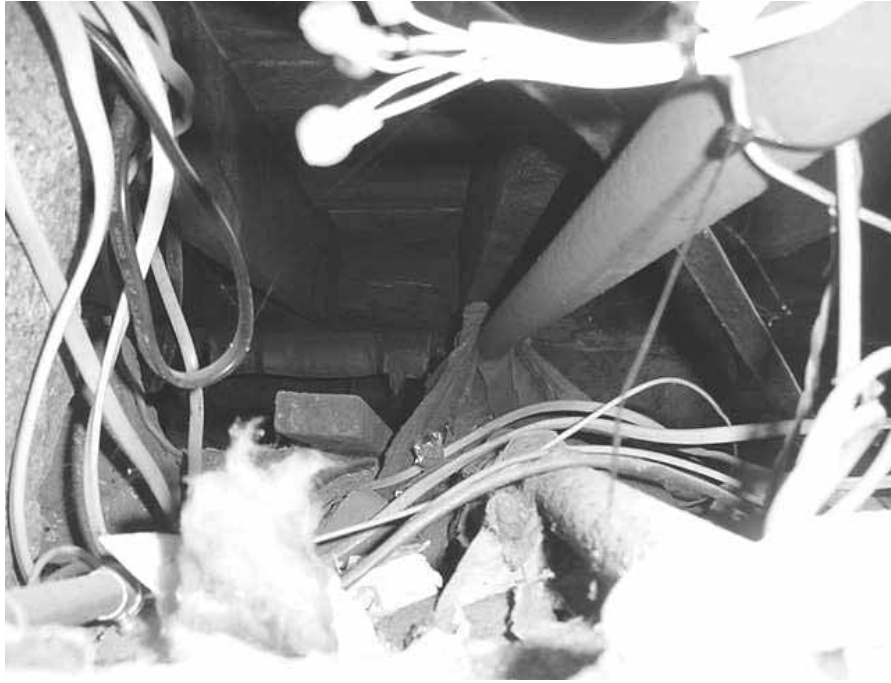
Picture 9

A number of sources of unimpeded cold air penetrating to enhance the stack effect exist in the basement. An opening into the 1981 wing crawlspace exists in the basement wall near the furnace (Picture 9). Of note was the existence of PAVs in opposing walls of the basement. One PAV is located in the east basement wall beneath the porch at the front of the building. The second PAV is located in a bulkhead door on the west basement wall. The likely purpose of these vents is to provide combustion (make up) air for the furnace. In the experience of MDPH staff, one combustion air vent of sufficient size would be appropriate to provide combustion air

Opening into the New Wing's Crawlspace in Basement Wall near the Furnace

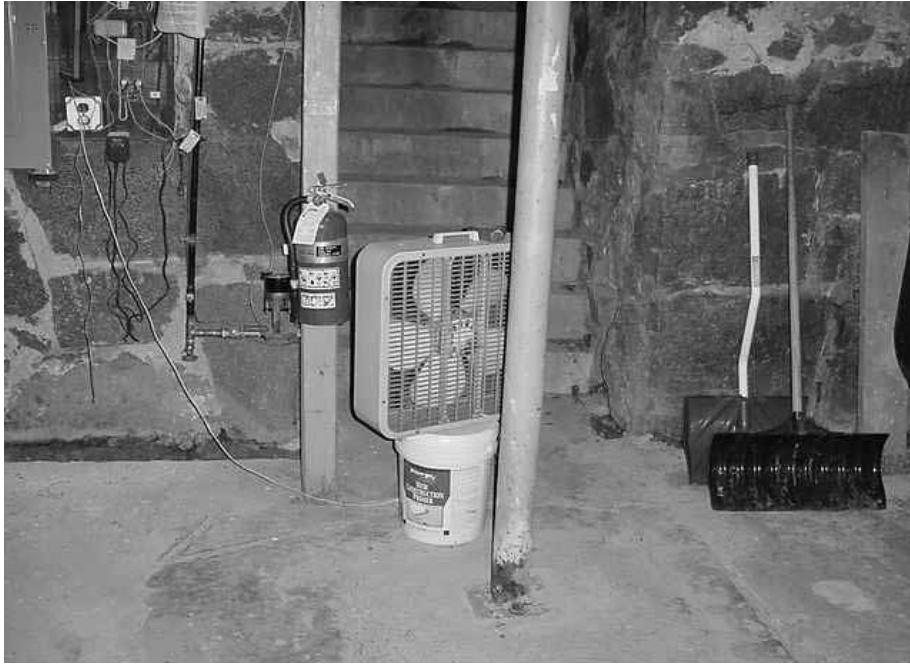
Picture 10

In addition to the two PAVs, a box fan was operating in the basement during the assessment (Picture 10). It is likely the fan was being used to dry the basement by drawing air from the bulkhead PAV. The operation of the fan, in addition to the stack effect created by the openings in the basement walls, would likely pressurize the basement to force air, odors and other pollutants upwards toward the basement door and occupied areas.

Box Fan Operating In Basement
